TECHNICAL NOTE 4263

EFFECT OF PRIOR AIR FORCE OVERTEMPERATURE
OPERATION ON LIFE OF J47 BUCKETS EVALUATED
IN A SEA-LEVEL CYCLIC ENGINE TEST

By Robert A. Signorelli, James R. Johnston, and Floyd B. Garrett

Lewis Flight Propulsion Laboratory
Cleveland, Ohio

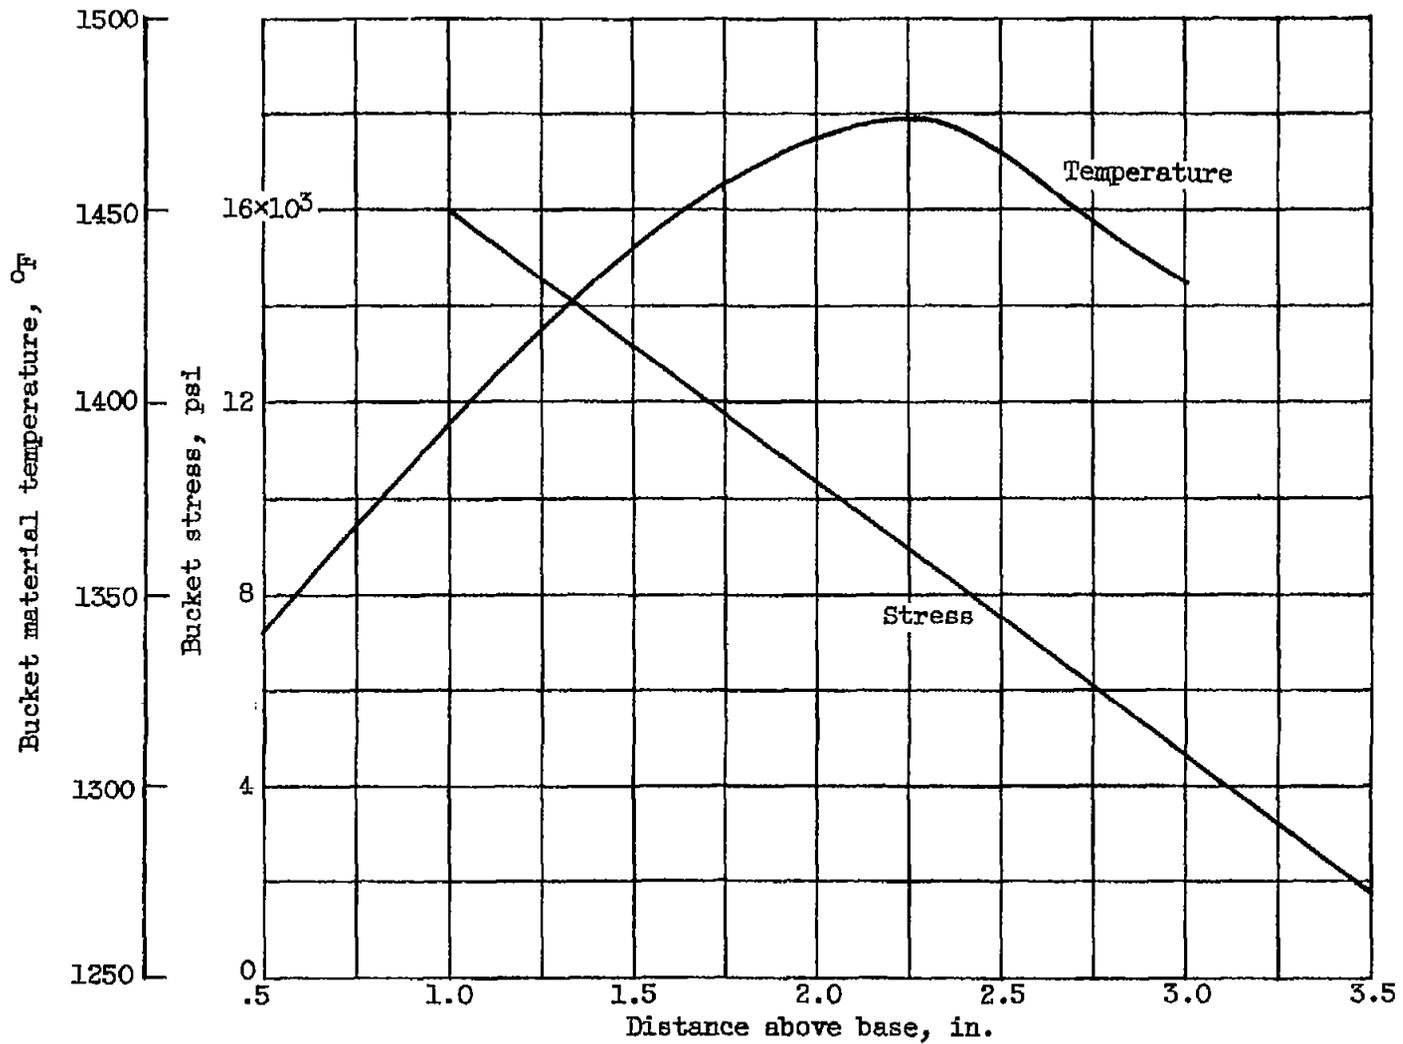
Figure 1. - Distributions of centrifugal stress and bucket temperature in J47 turbine bucket.

Stress and temperature distribution in buckets. - Centrifugal stress and temperature distributions in bucket airfoils are shown in figure 1. The centrifugal stress was calculated using cross-sectional areas, density, and rotational speed (ref. 6). The temperature distribution shown in figure 1 was obtained before the engine test was started. To do this, the turbine wheel was fully bucketed with standard Air Force stock buckets, and the engine was operated for a sufficient time to obtain equilibrium condition at full power. Temperature measurements were obtained from thermocouples imbedded in four of the turbine buckets.

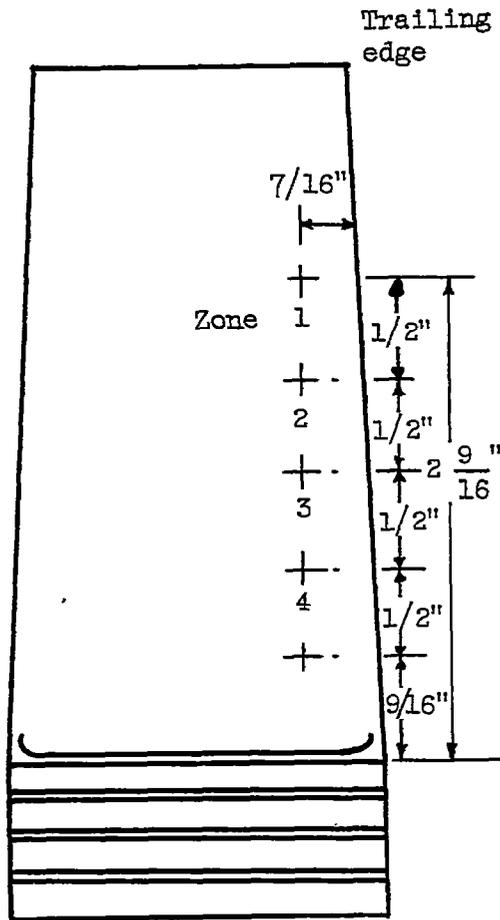
Figure 2. - Scribed marks for elongation measurements.

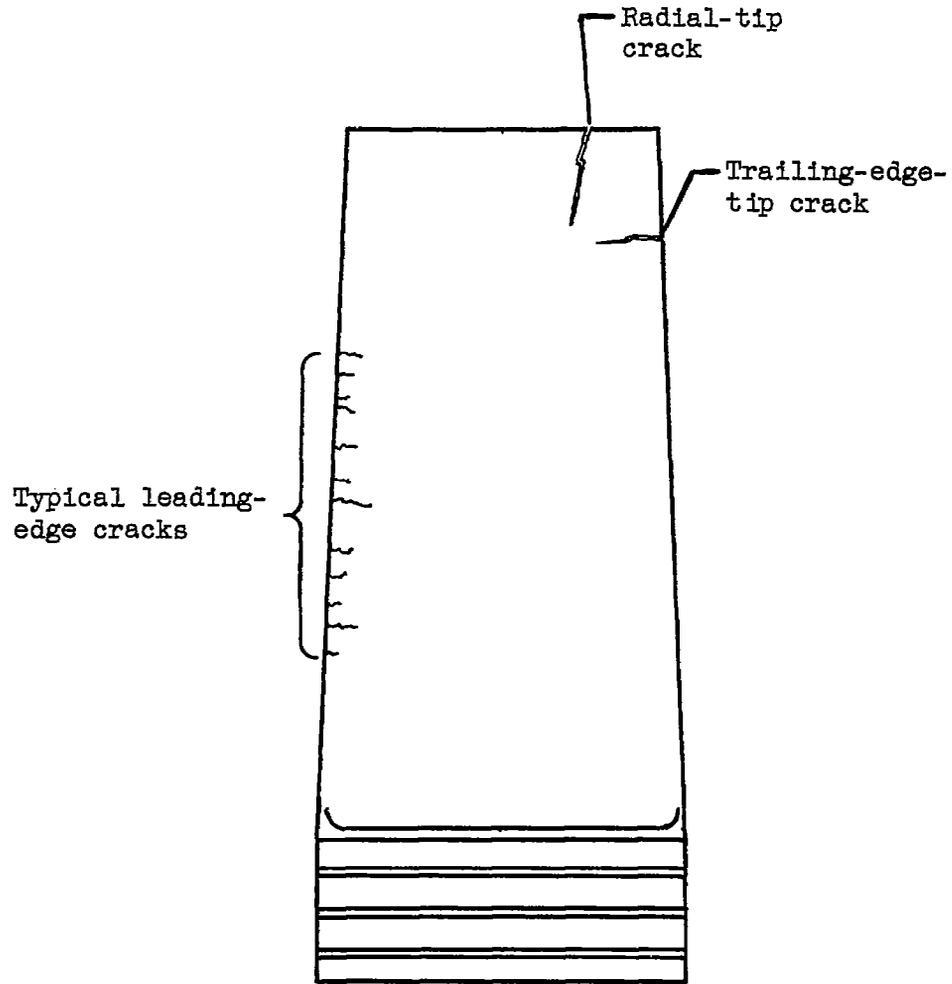
Figure 3. - Crack classification.

Macroexamination of buckets. - Buckets were examined for cracks, using post-emulsifying zyglo, after intervals of about 40 hours of rated-speed operation. The cracks were classified (fig. 3) as follows: (1) leading edge, (2) radial tip, and (3) trailing-edge tip. To follow the progression of cracks, photos were taken of a sample of about 20 cracked buckets after the 198-hour inspection and after every subsequent inspection. A double exposure was taken of the cracked buckets; the first exposure used an ultra-violet light to define the cracks, and a normal flash was used to show the entire bucket.

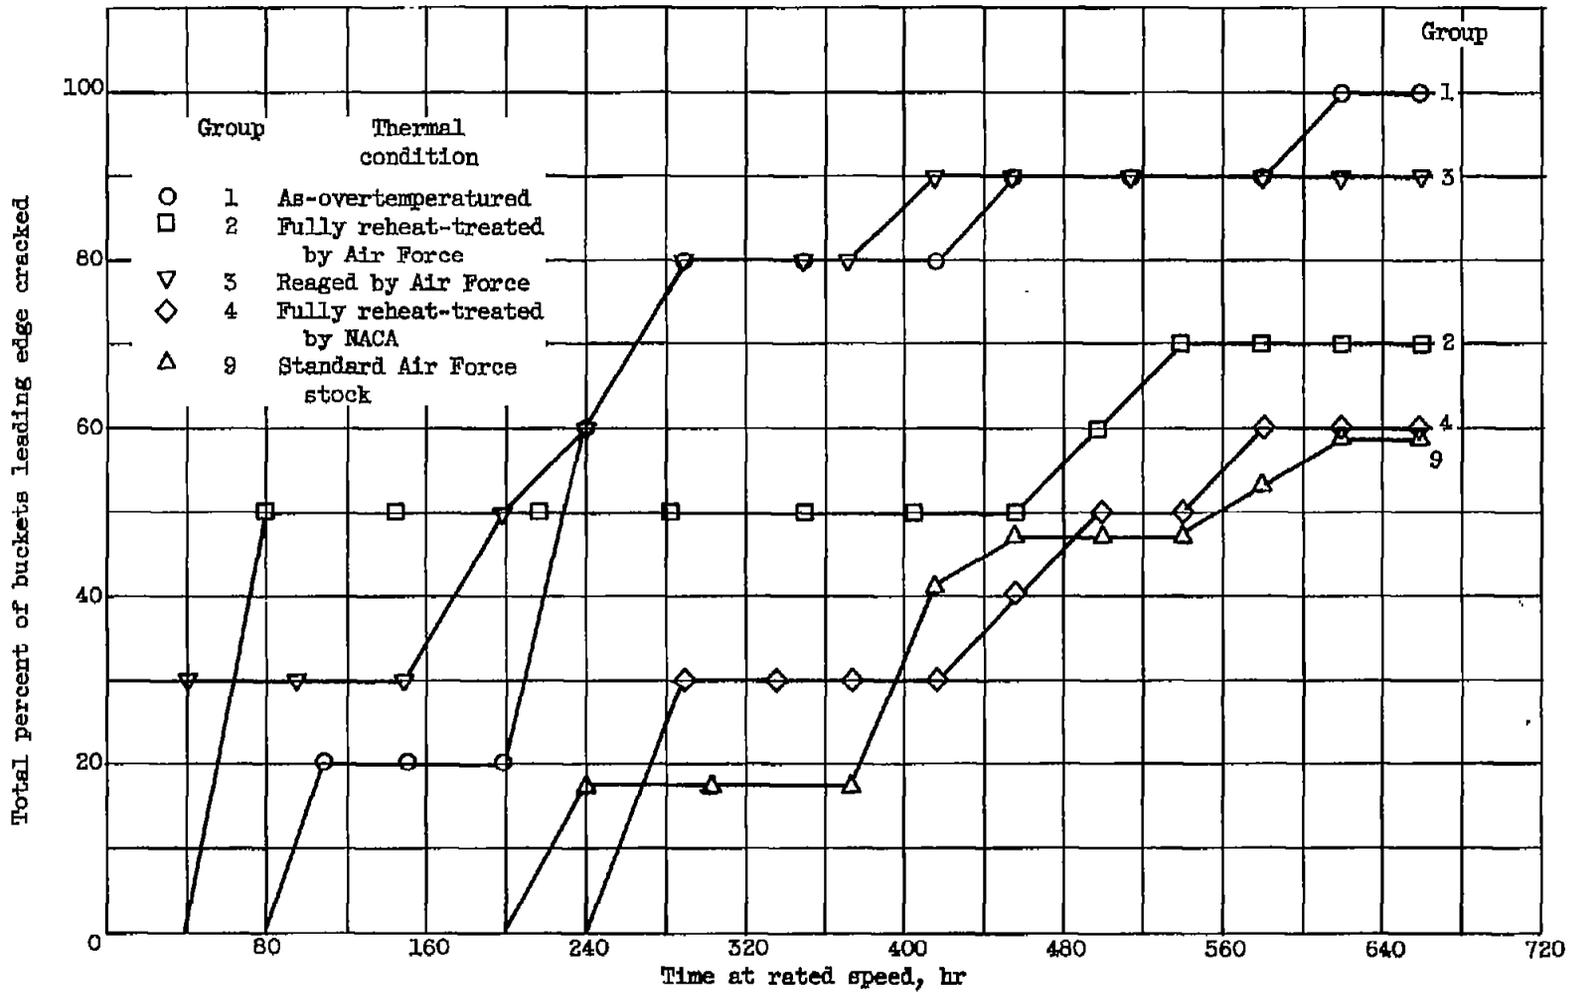
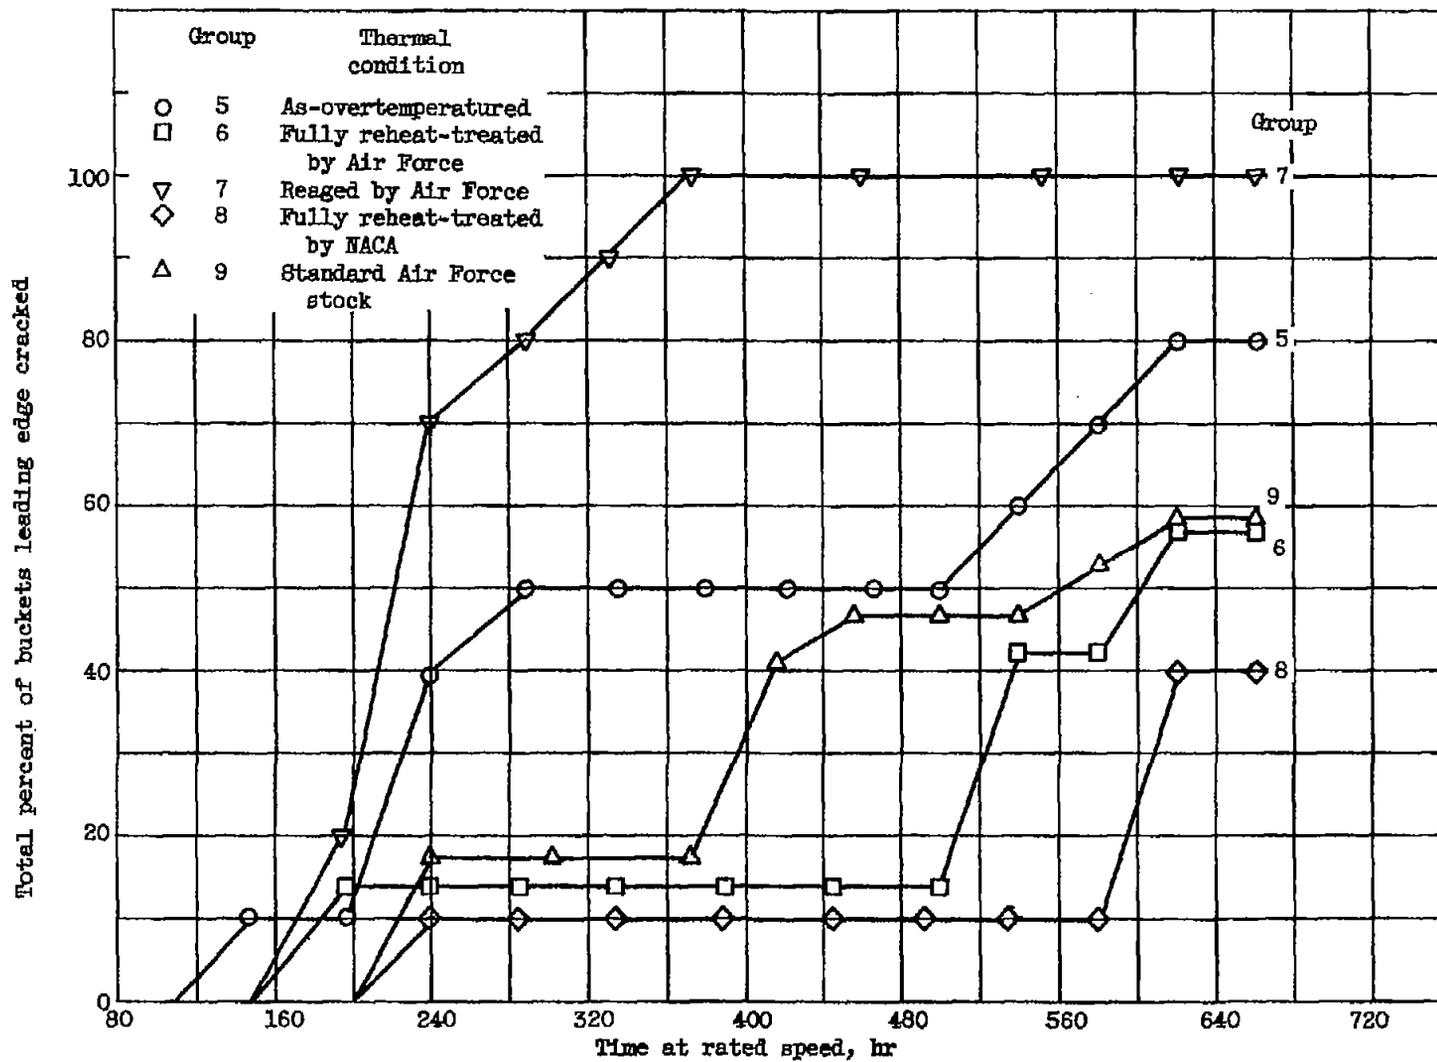
(a) Engine A buckets.

Figure 5. - Leading-edge cracking with time at rated speed.

(b) Engine B buckets.

Figure 5. - Concluded. Leading-edge cracking with time at rated speed.

Leading-edge cracking. - The leading-edge cracking data have been plotted in figure 5. Figure 5(a) shows the cumulative percentages of buckets with leading-edge cracks for each of the groups of buckets originally obtained from engine A (groups 1 to 4). The percentages of buckets with leading-edge cracks is plotted against engine test time. Figure 5(b) shows similar data for the groups of buckets originally obtained from engine B (groups 5 to 8). For comparison, both figures show leading-edge cracking data for the standard Air Force stock buckets (group 9). Buckets of the as-overtempered groups (1 and 5) and the overtempered and reaged groups (3 and 7) developed leading-edge cracks more readily than buckets in the other groups. After 240 hours of operation, leading-edge cracks were present in 60 percent of the buckets of groups 1 and 3 and in 40 and 70 percent, respectively, of buckets of groups 5 and 7 (fig. 5). Only 18 percent of the standard Air Force stock buckets (group 9) had leading-edge cracks after 240 hours. However, the group 9 buckets were new when they were installed in the engine test, while all other groups had a prior service life. The service life of the buckets is not known, but the flight time on the engines was 209 and 242 hours, respectively, for engines A and B. Perhaps the prior service life, rather than overtemperature, accounts for the larger number of leading-edge cracked buckets.

The overtempered and reheat-treated buckets (groups 2, 4, 6, and 8) had less tendency to form leading-edge cracks than the buckets of the as-overtempered groups and the overtempered and aged groups. The incidence of leading-edge cracking in groups 2, 4, 6, and 8 was similar to that in group 9, the standard buckets. Group 2 had a large number of buckets (50 percent) with leading-edge cracks after 80 hours but had no additional leading-edge cracked buckets until 480 hours. Thus, the reheat treatment recovered at least a portion of the resistance to leading-edge cracking that the as-overtempered buckets lost from service life or from overtemperature operation.

In this investigation, resistance to leading-edge cracking appears to have been increased by the full standard heat treatment of as-overtemperated buckets. As may be noted in figure 5, groups 2, 4, 6, and 8 had lower incidences of leading-edge cracking than did the as-overtemperated groups, 1 and 5. In fact, the incidence of leading-edge cracking of the fully reheat-treated groups was about the same as the new standard-group buckets.

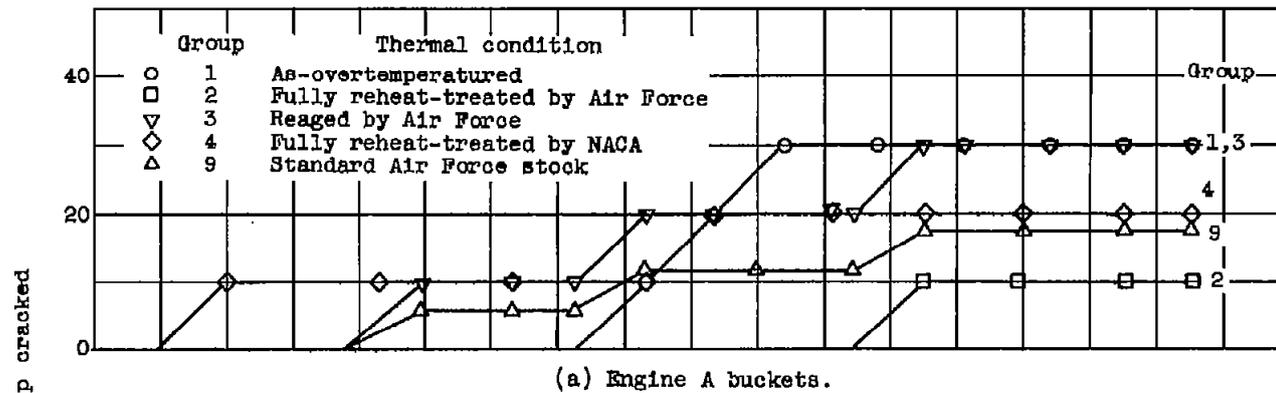
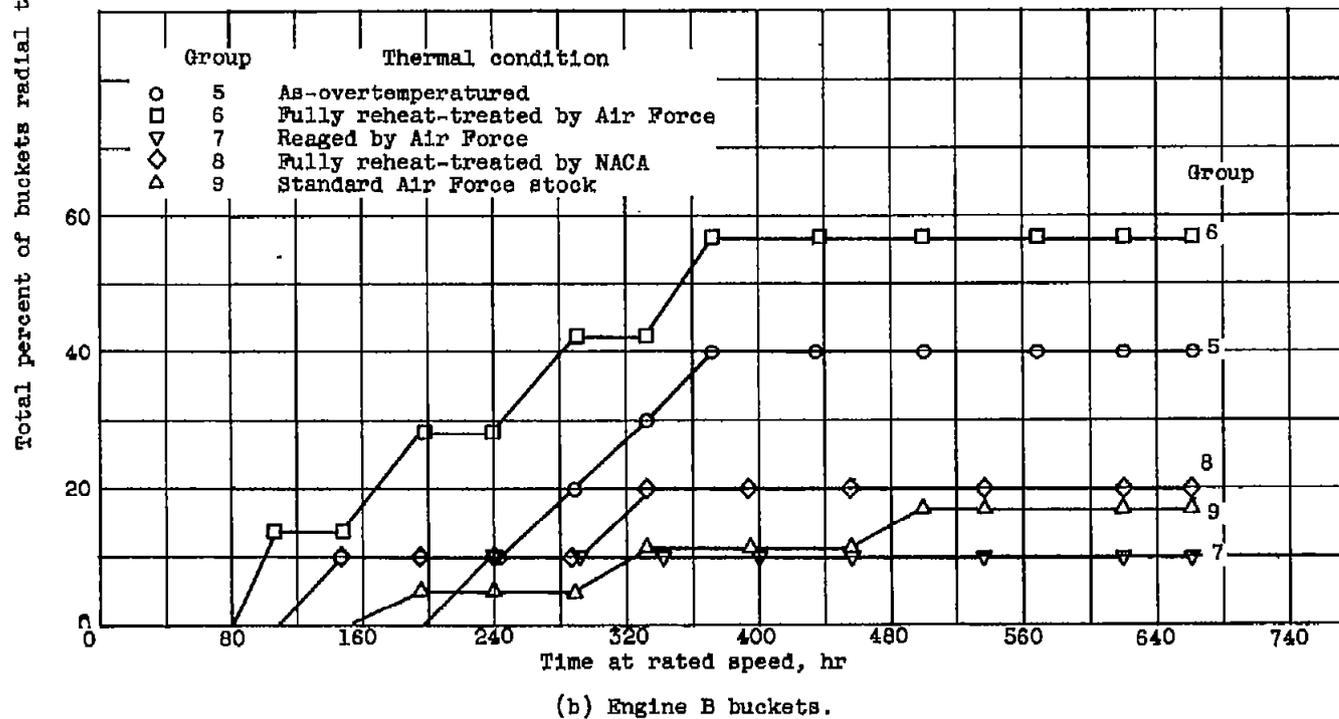
Figure 6. - Radial-tip cracking with time at rated speed.

Radial-tip cracking. - The incidence of radial-tip cracking is shown in figure 6. The difference between the bucket groups in the incidence of radial-tip cracking was less than that obtained for leading-edge

4567
cracking. The data in figure 6(a) show little difference in incidence of radial-tip cracking among bucket groups from engine A. Upon first examination of figure 6(b), however, there might appear to be a significant difference in the incidence of radial-tip cracking among bucket groups from engine B. Particularly, it would appear that the group given a full reheat treatment by the Air Force (group 6) has a greater incidence of tip cracking than does the group given the full reheat treatment by the NACA (group 8). The noted difference is not believed to be significant, however, since, in the case of the similar groups of engine A (groups 2 and 4) no detrimental effect of the Air Force treatment was noted; and, even in the case of the previously discussed leading-edge cracking (fig. 5(b)), the effect of the full reheat treatment was about the same, whether given by the Air Force (group 6) or NACA (group 8).

The effect of reaging alone on radial-tip cracking was not consistent among the bucket groups from the two engines. The overtemperated and reaged buckets of engine A (group 3) had a relatively high incidence of radial-tip cracking, while the equivalent group from engine B (group 7) had a low incidence. In general, it is felt that no consistent relation has been found between reheat treatment and incidence of radial-tip cracking, and reheat treatment has not been found to be beneficial in reducing the incidence of tip cracking.

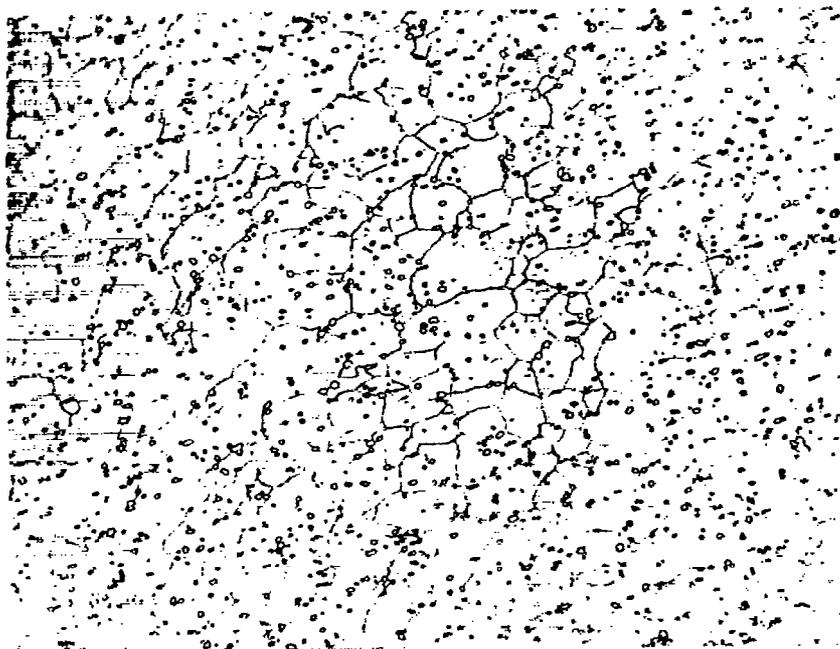
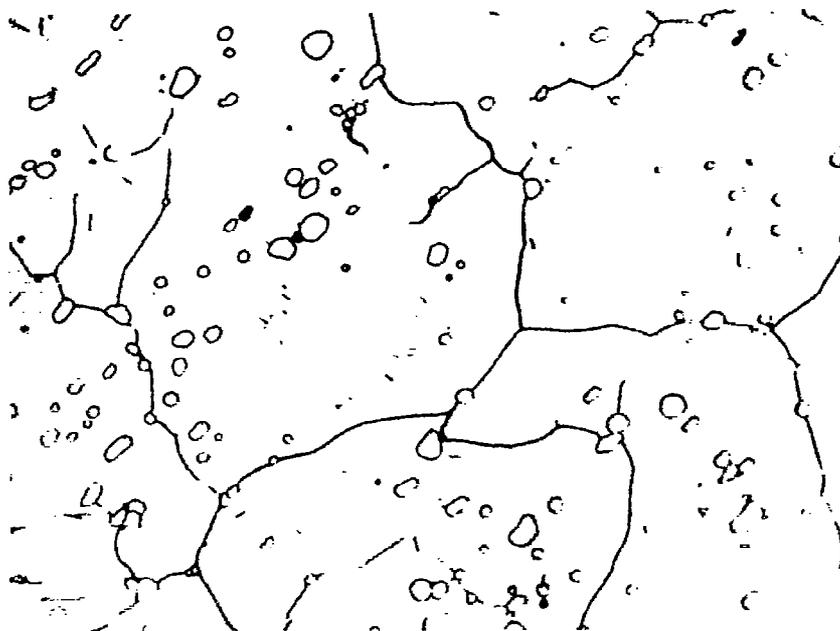
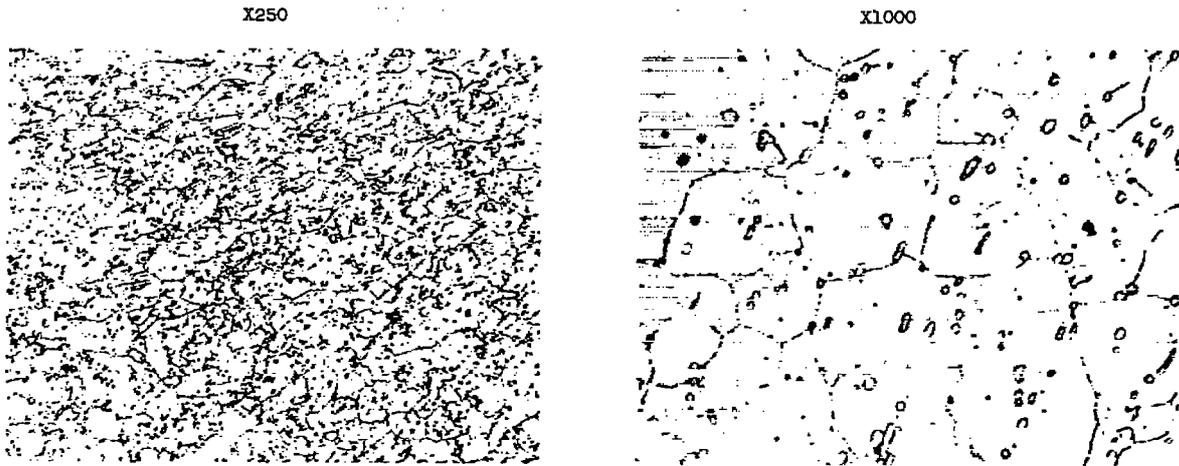
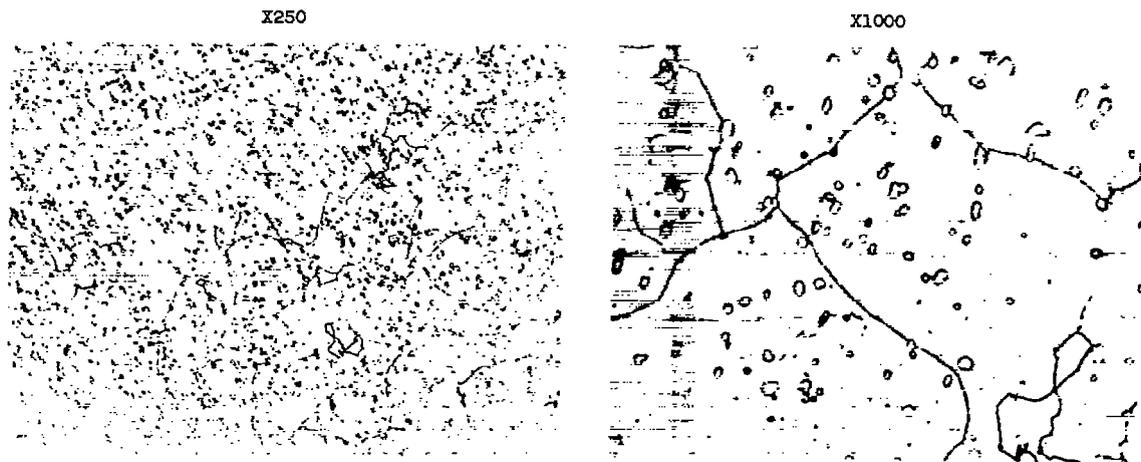
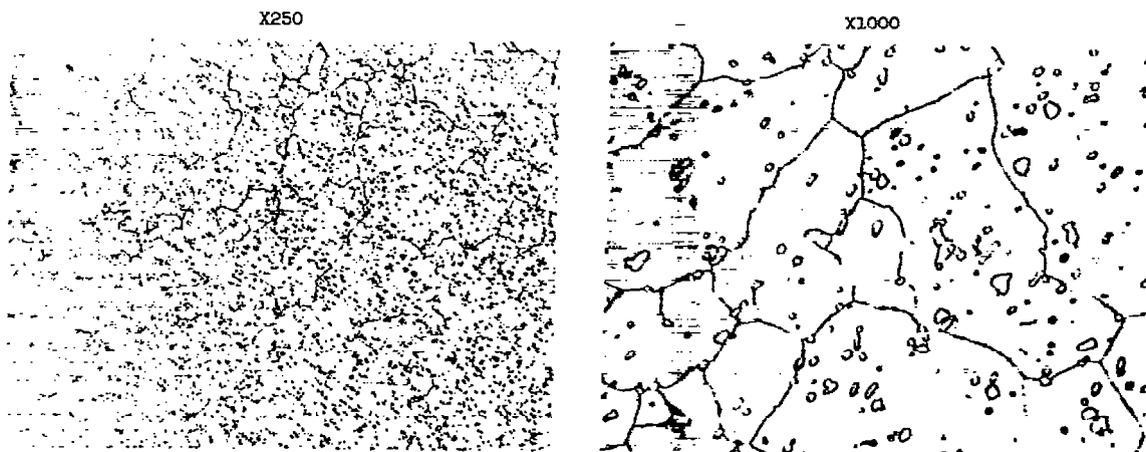
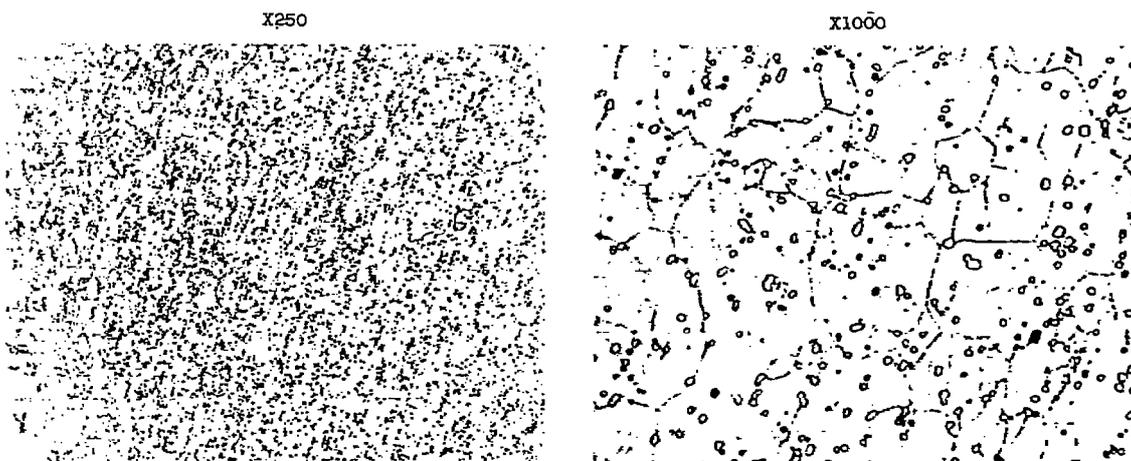
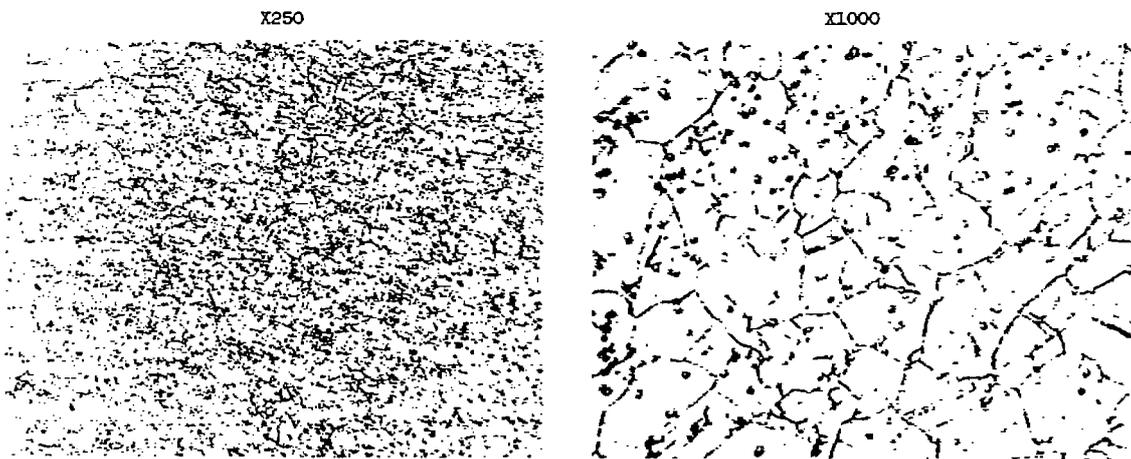
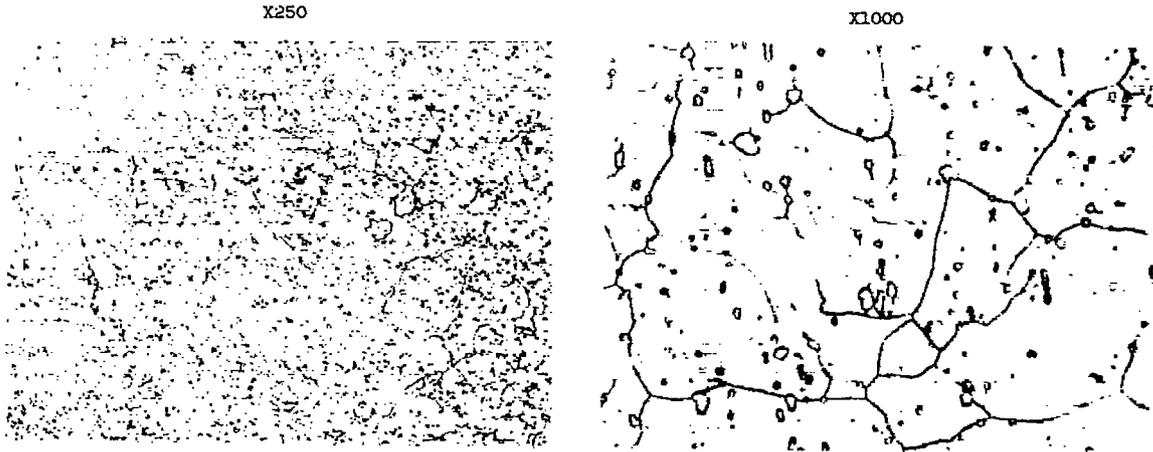
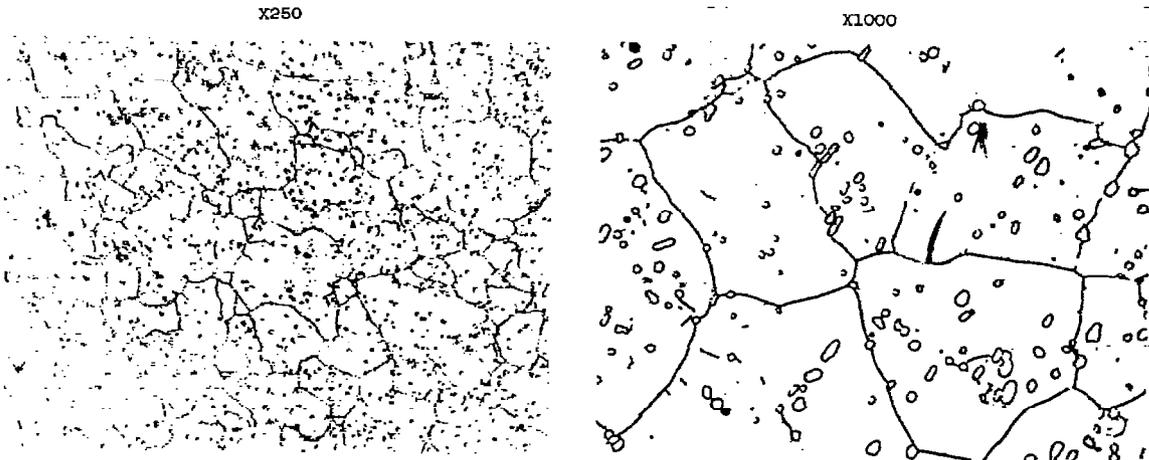
(a) Group 9, standard S-816.

Figure 7. - Microstructures of untested buckets.
Etchant, aqua regia plus glycerol.

Group 1, overtemperated in engine A

Group 5, overtemperated in engine B

(b) As-overtemperated buckets.

Group 2, overheated in engine A and reheat-treated

Group 6, overheated in engine B and reheat-treated

Group 3, overheated in engine A and reaged.

Group 7, overheated in engine B and reaged

(d) Buckets overheated and reaged by Air Force.

Group 4, overheated in engine A and reheat-treated

Group 8, overheated in engine B and reheat-treated

Untested buckets. - Typical microstructures of bucket from the overtemperated groups and the standard group before engine testing are shown in figure 7. The standard heat-treated S-816 alloy bucket (fig. 7(a)) has large, stable, columbium-tantalum carbide precipitates in the matrix and continuous grain-boundary precipitation. The as-overtemperated bucket microstructures (groups 1 and 5) in figure 7(b) show agglomeration and spheroidization of grain-boundary precipitates that have been associated with overtemperature, as described earlier. Although the photomicrographs of the specific buckets of figure 7(b) indicate slightly more hyphenation of grain-boundary precipitation for group 1 than for group 5, examination of microstructures of a number of buckets from groups 1 and 5 indicates that the degree of hyphenation is about equivalent for the two groups of buckets. Buckets of groups 2, 4, 6, and 8, overtemperated and reheat-treated, are shown in figures 7(c) and (e). The microstructures are typical of S-816 in the normal heat-treated condition. The microstructural evidence associated with overtemperature is no longer visible. The overtemperated and reaged buckets of groups 3 and 7 are shown by the microstructures in figure 7(d). The precipitation

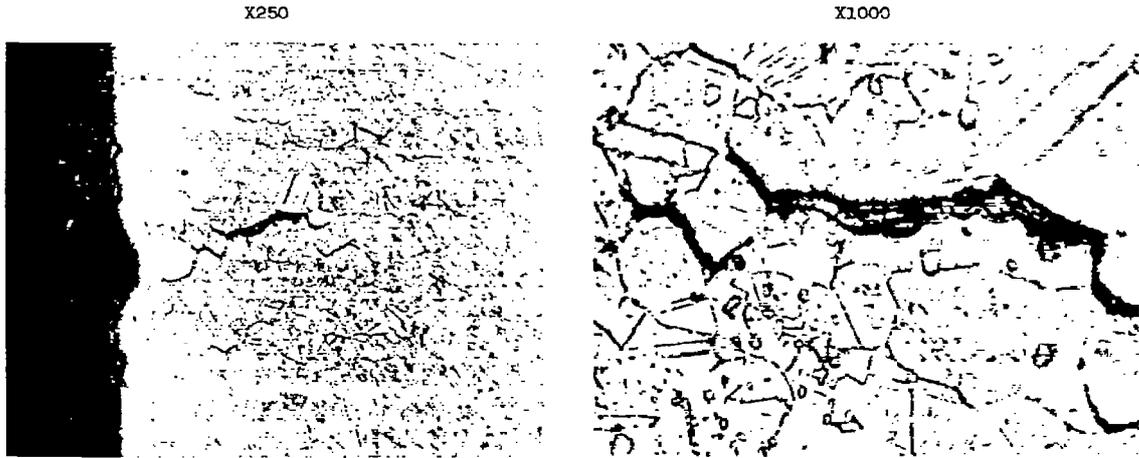
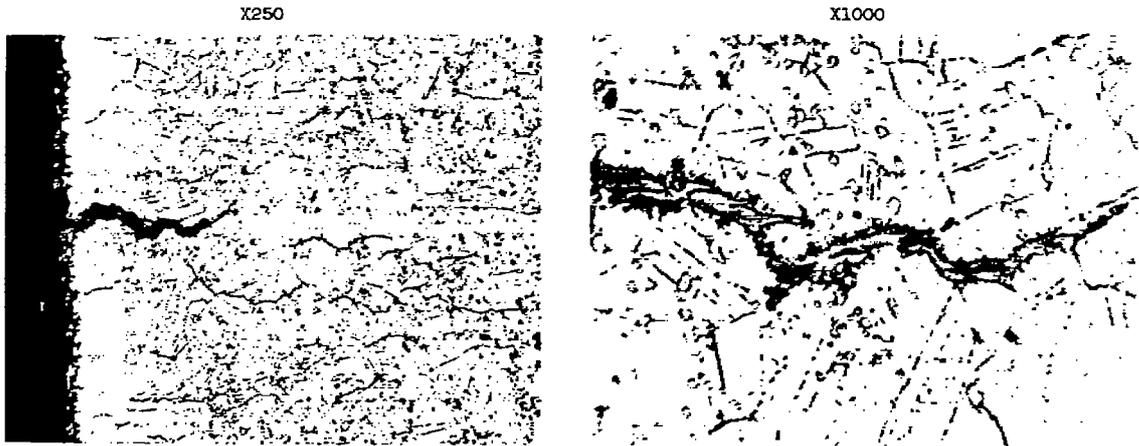
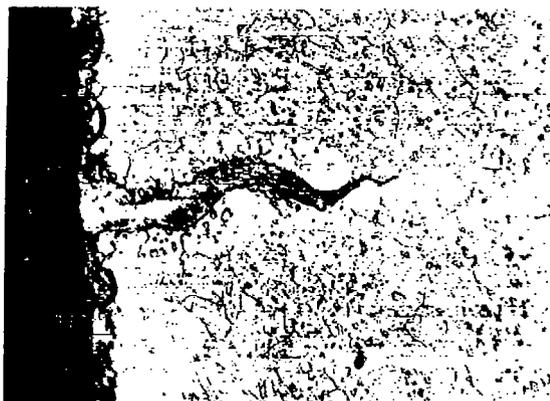
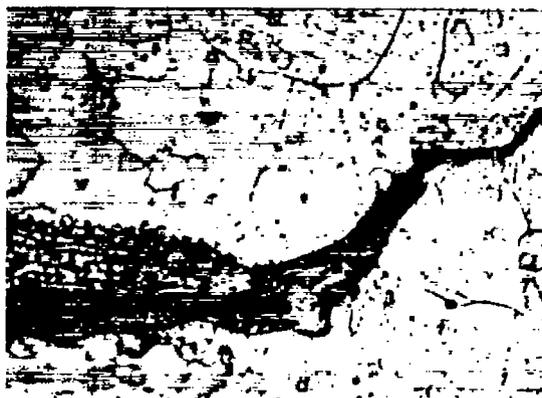
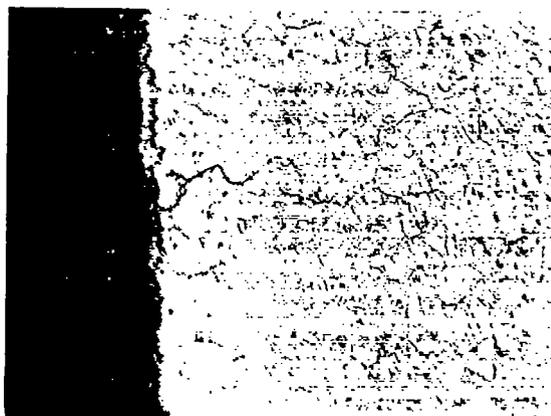
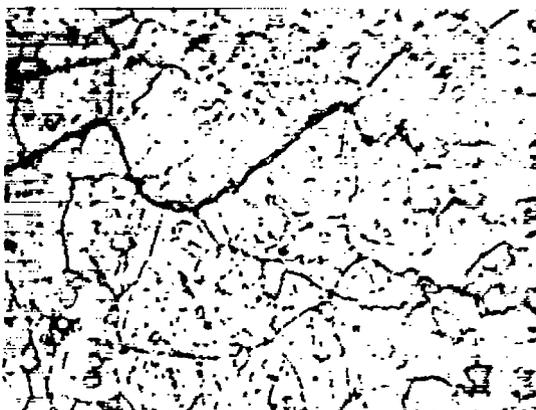
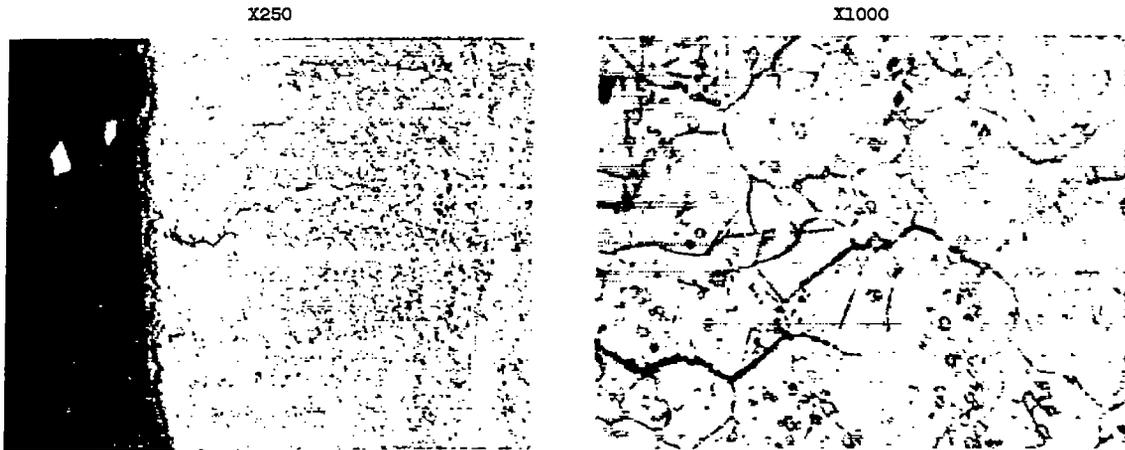
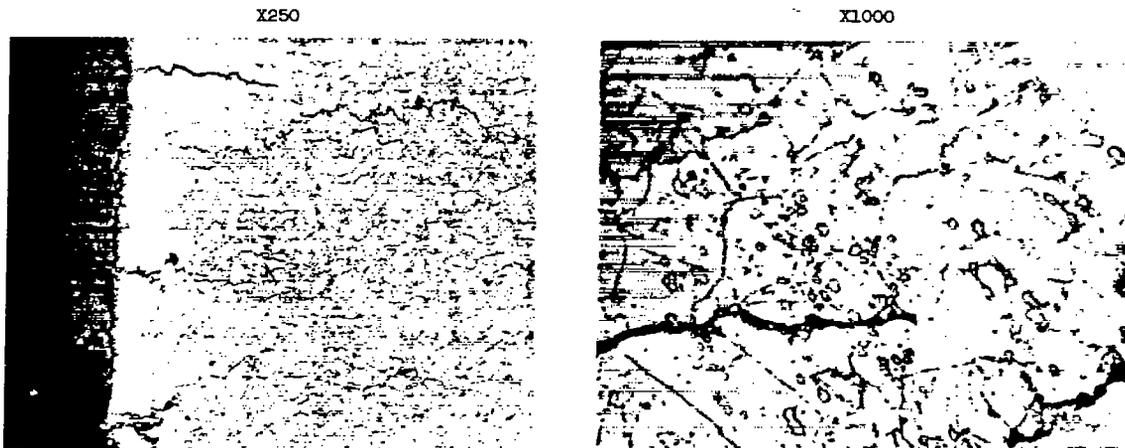
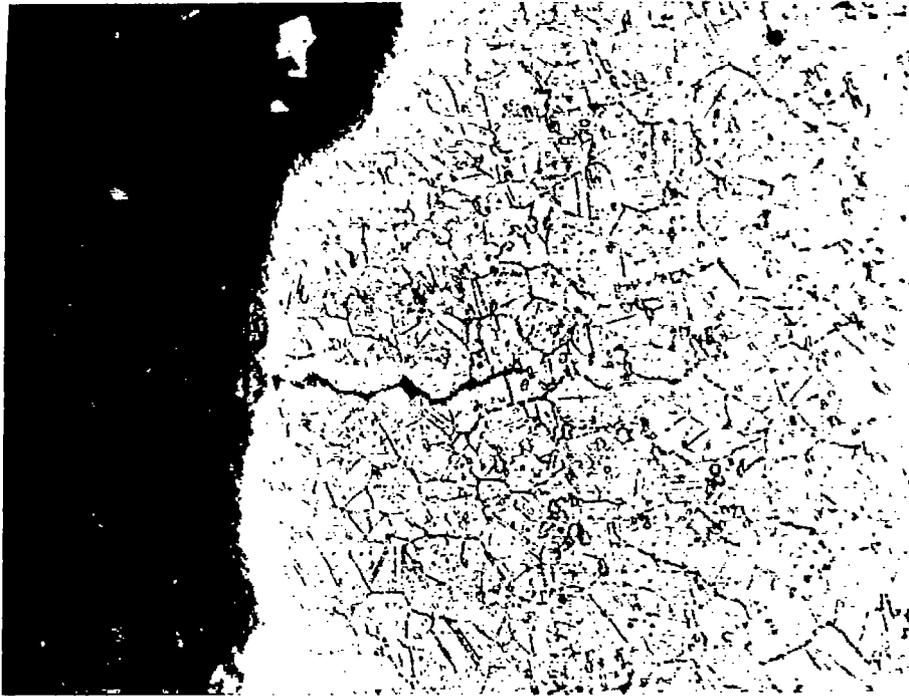
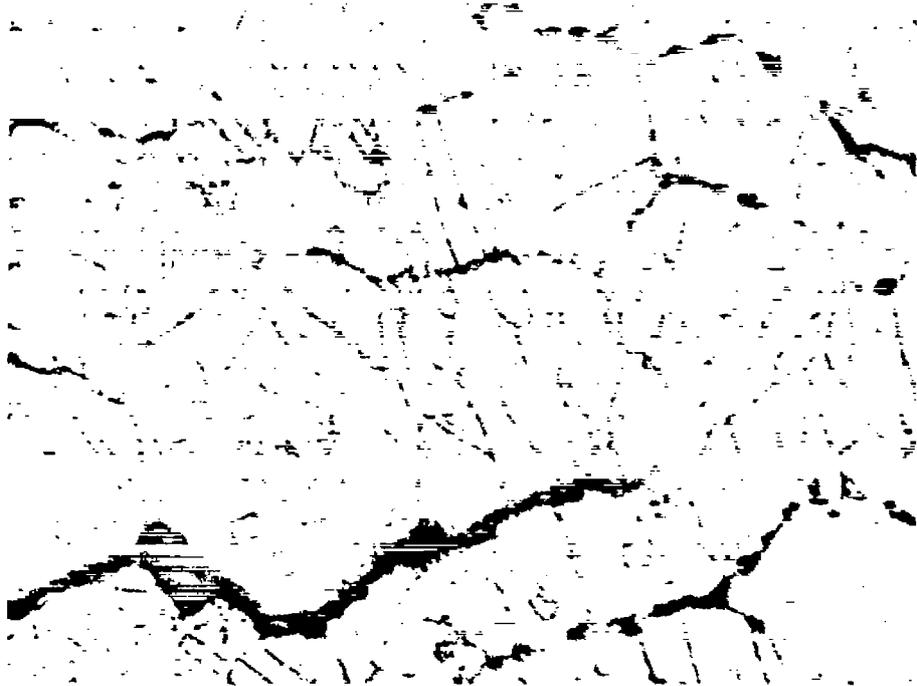
Group 1, overheated in engine A

Group 5, overheated in engine B

Figure 8. - Microstructures after engine test.

Group 2, overheated in engine A and reheat-treated

Group 6, overheated in engine B and reheat-treated

Group 3, overheated in engine A and reaged

Group 7, overheated in engine B and reaged

(d) Group 9, standard S-816.

Engine-tested buckets. - Microstructural studies of buckets after engine testing are presented in figure 8. Buckets of all groups showed an advanced stage of aging, with little or no microstructural difference among groups. Several small leading-edge cracks are also shown in the photomicrographs. Small cracks with less oxidation than the larger cracks were photographed because oxidation obscured the surfaces of larger cracks and hampered classification of cracks as intergranular or transgranular.

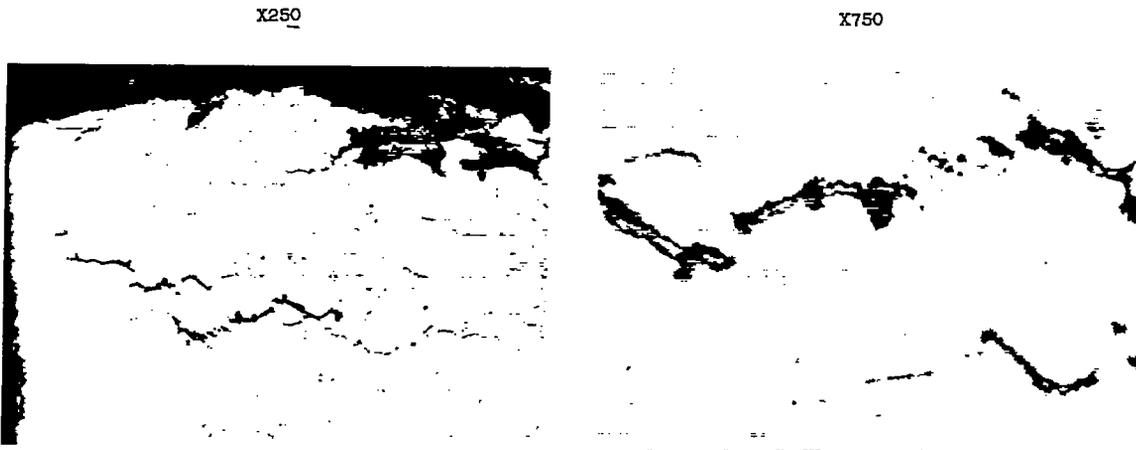
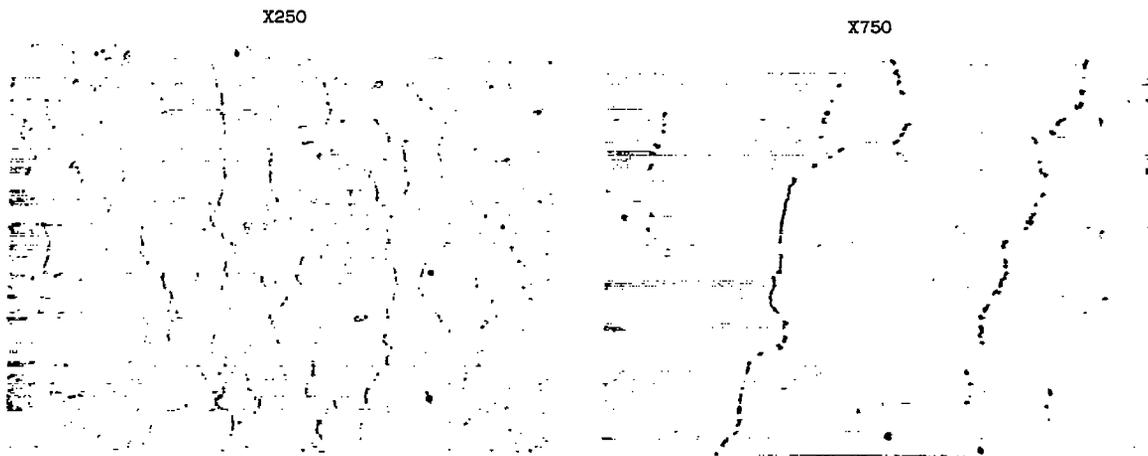
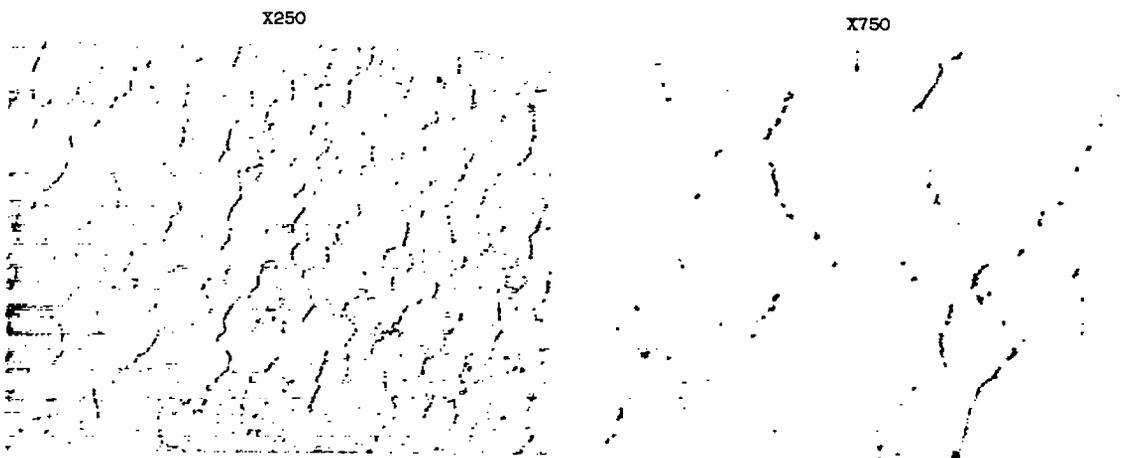
(a) As-temperatured.

(b) As-temperatured.

(c) Standard S-816.

Figure 9. - Voids in as-temperatured and standard S-816 buckets after 660 hours at rated speed (unetched).

In addition to the continuous cracks near the leading edge, there were clusters of voids present in the grain boundaries of buckets. The voids were found in buckets from every group, but only specimens from the as-overtempered and the standard groups are shown in figure 9. The voids are in the grain boundaries transverse to the direction of centrifugal stress in the airfoil. They are found near, but not at, the leading edge and extend inward for a distance of about 0.2 inch.

As indicated in the results, clusters of voids were observed in the examination of microstructures after engine testing (fig. 10). The voids do not appear to be intergranular oxidation or rupture tears may be evidence supporting a theory that intergranular failure of metals at higher temperatures is caused by migration and collection of interstitial gases or vacant lattice sites, as suggested by Parker in 1944 (ref. 7) and others more recently (ref. 8). These voids have been seen in rupture specimens by others (refs. 9 and 10) and may be associated with the failure mechanism of leading-edge cracks.

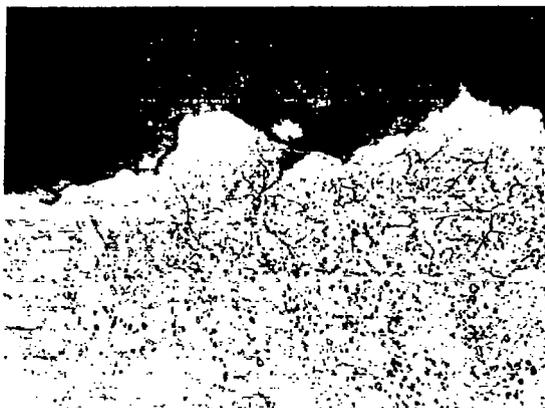
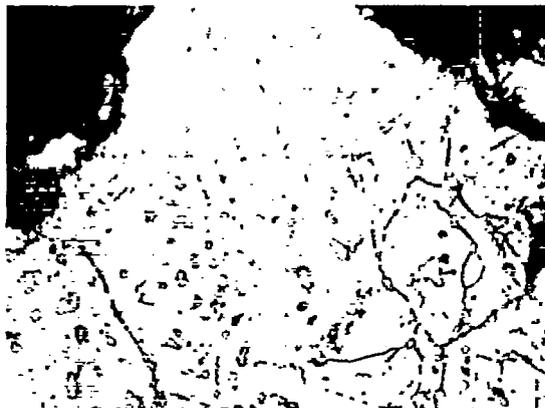
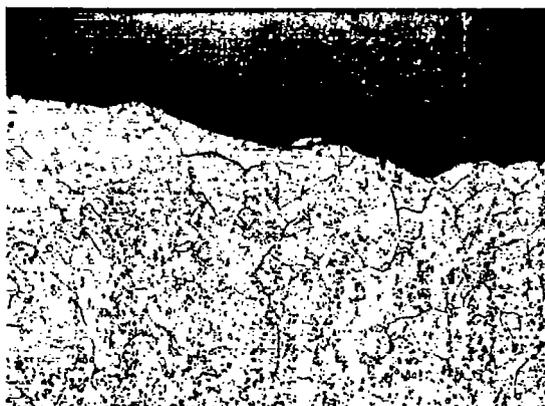
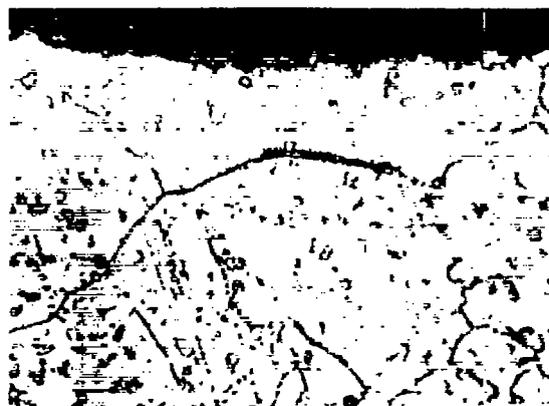
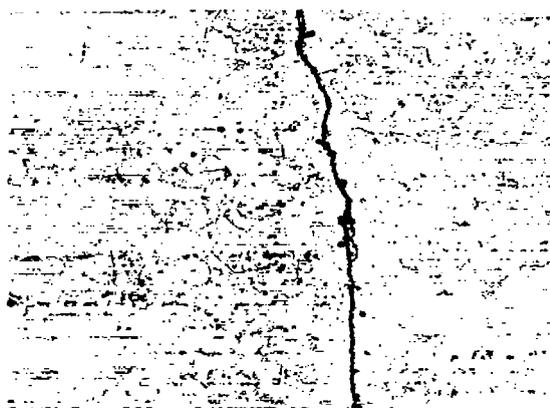
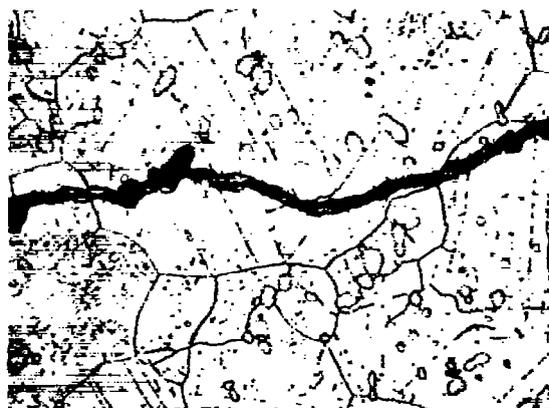
Intergranular near leading edge of bucket

Transgranular portion of fracture surface following above
 (a) Bucket failure progressing from leading-edge crack.

(b) Radial tip crack.

Figure 10. - Fracture surface of failed bucket and radial tip crack.

The fracture surface of the one bucket that fractured in this investigation is shown in figure 10. The fracture surface is near the leading edge where failure began and at a point near the center of the chord length. The fracture appears intergranular near the leading edge and transgranular near midchord. The failure was propagated by fatigue from a leading-edge crack until the load-carrying area was reduced sufficiently to cause tensile failure.

A typical radial-tip crack shown in figure 10 is a transgranular fatigue failure. Buckets ran for 500 hours with such radial-tip cracks and did not fracture.
